Diagnosing External Wall Debond via Infrared Thermography: the Old and New Approach

Ir Dr Wallace LAI, Lydia Chiu, Dr. Janet Sham
Department of Land Surveying and Geo-informatics
The Hong Kong Polytechnic University

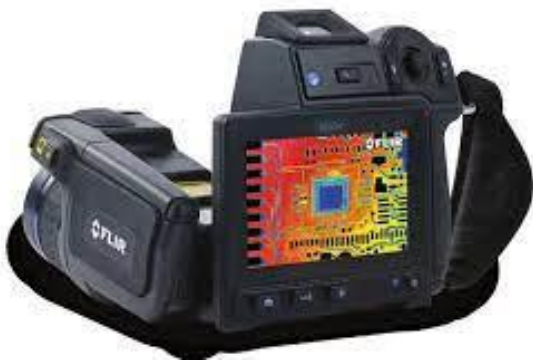
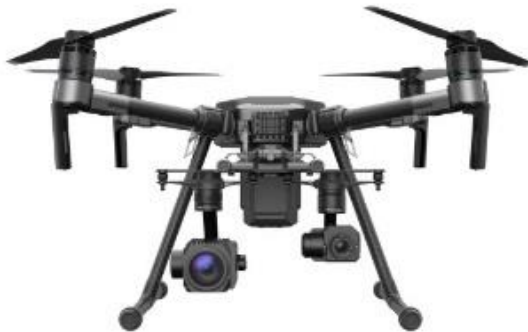
Issue 1 (2009)	Issue 2 (2022)
Spectral range: 2 – 14 μm (MWIR and LWIR) Spatial resolution (IFOV): at least 1.3 mrad	Spectral range: 7 – 14 μm (MWIR and LWIR) Spatial resolution (IFOV): at most 1.3 mrad
Angle of incidence should be $< 40^\circ$ <ul style="list-style-type: none">For high-rise buildings, robotic device (e.g. UAV) equipped with radiometric IR camera could be used

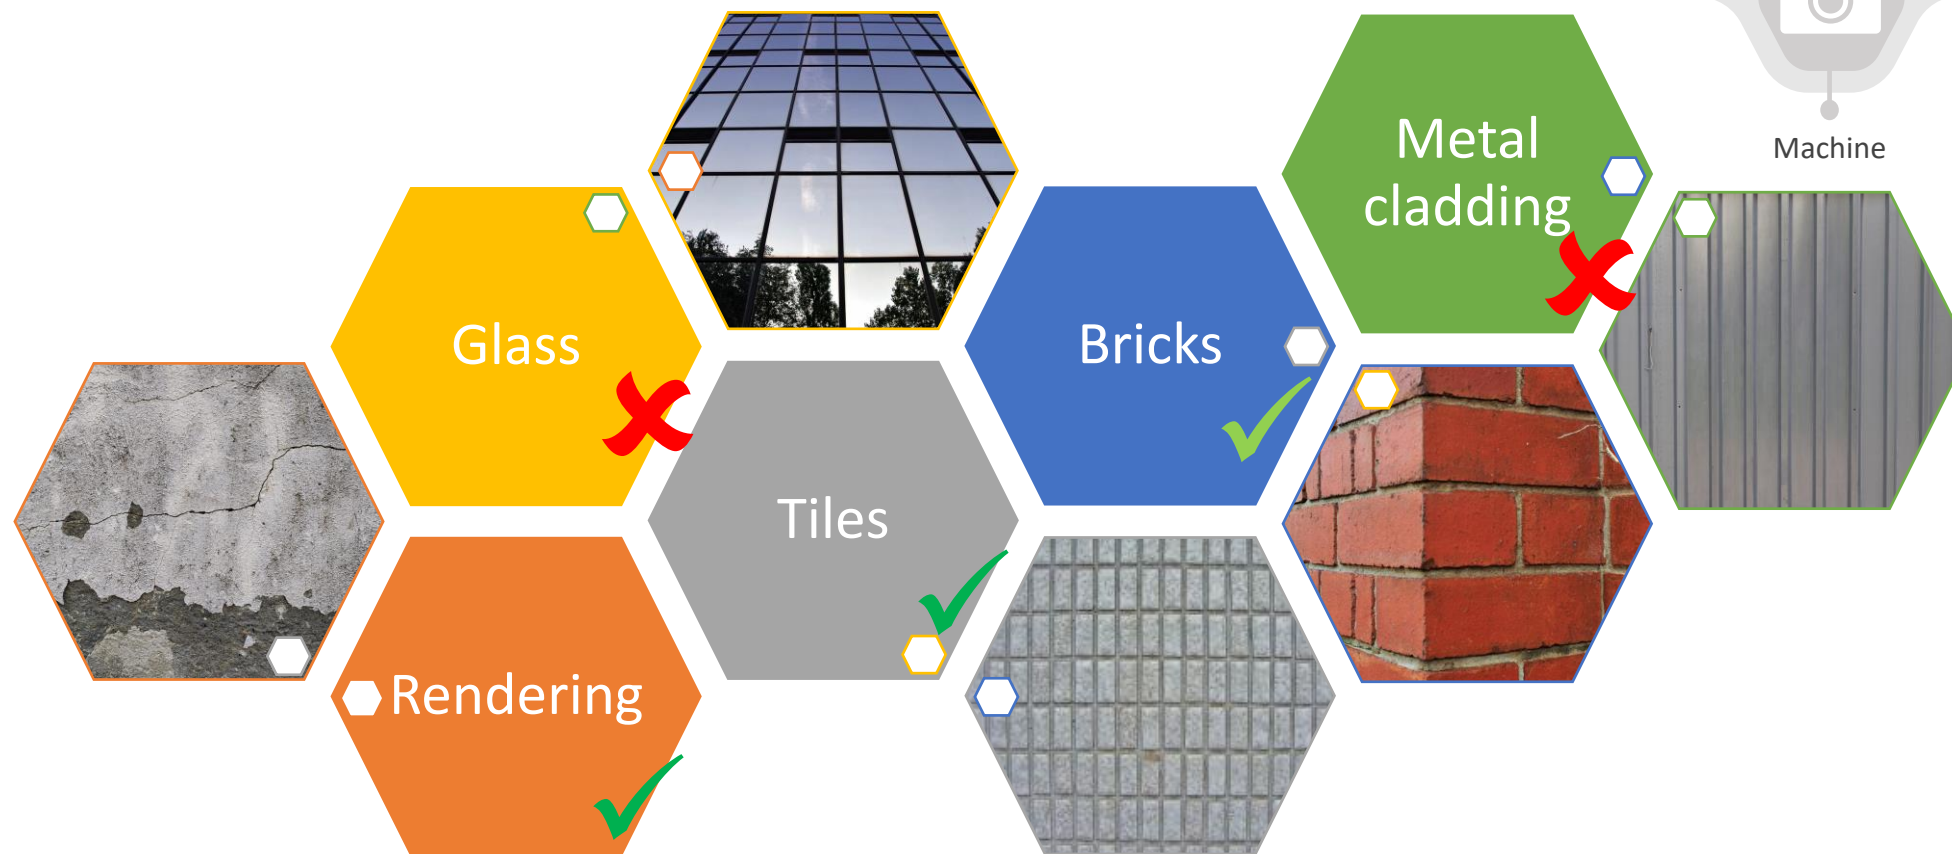
Material – Target

Depends on the emissivity of the material

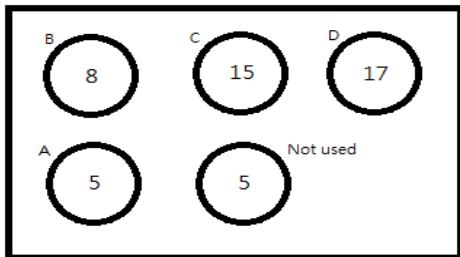
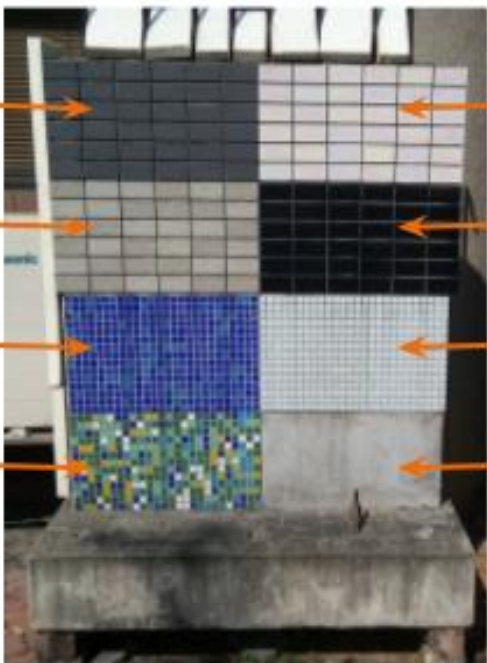
8 demonstrates the depth of debond (in mm)

- Tile: Matt Black
Size: 95mm x 45mm
- Tile: Grey Ceramic
Size: 95mm x 45mm
- Tile: Blue Mosaic
Size: 19mm x 19mm
- Tile: Mixed-color Mosaic
Size: 19mm x 19mm

- Tile: Reflective White
Size: 95mm x 45 mm
- Tile: Smooth Black
Size: 95mm x 45 mm
- Tile: White Mosaic
Size: 19mm x 19 mm
- Tile: Fair-face Concrete
Size: N/A

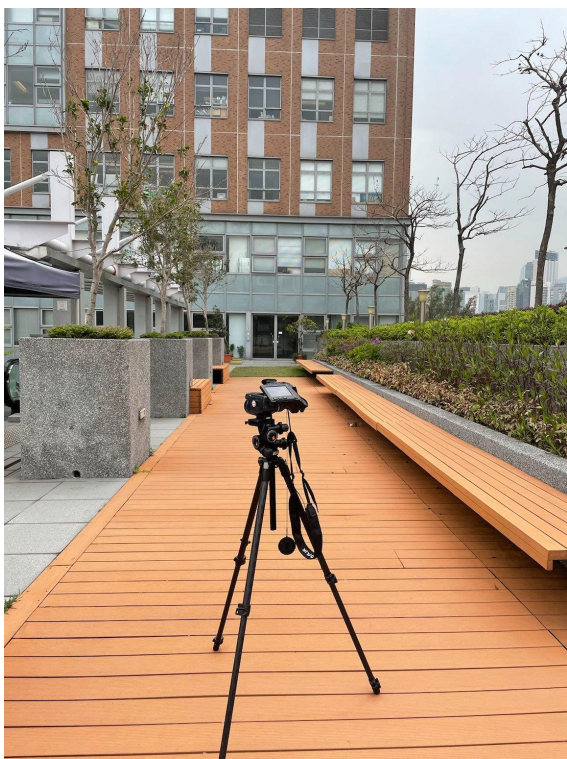
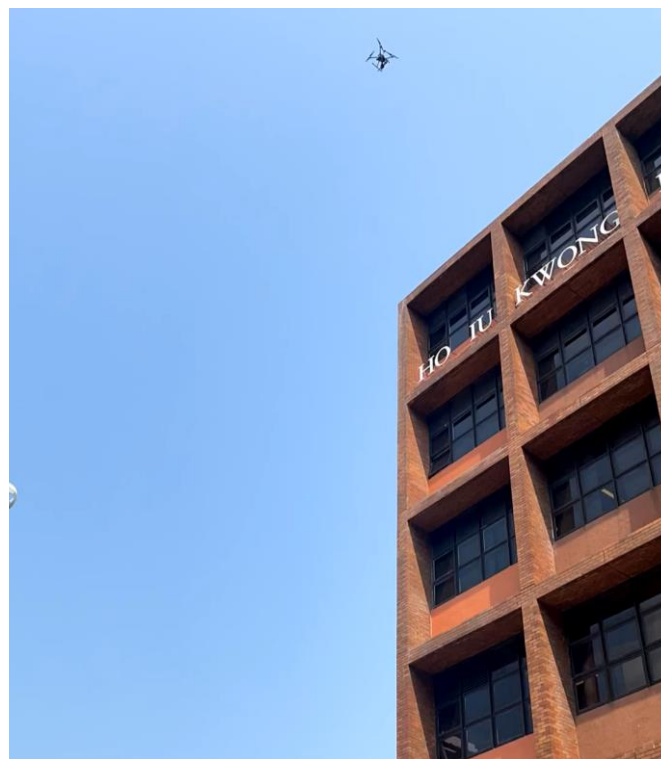
Issue 1 (2009)	Issue 2 (2022)
Ground-based	Ground-based or UAV

Normal case – ground-based High-rise buildings – with UAV

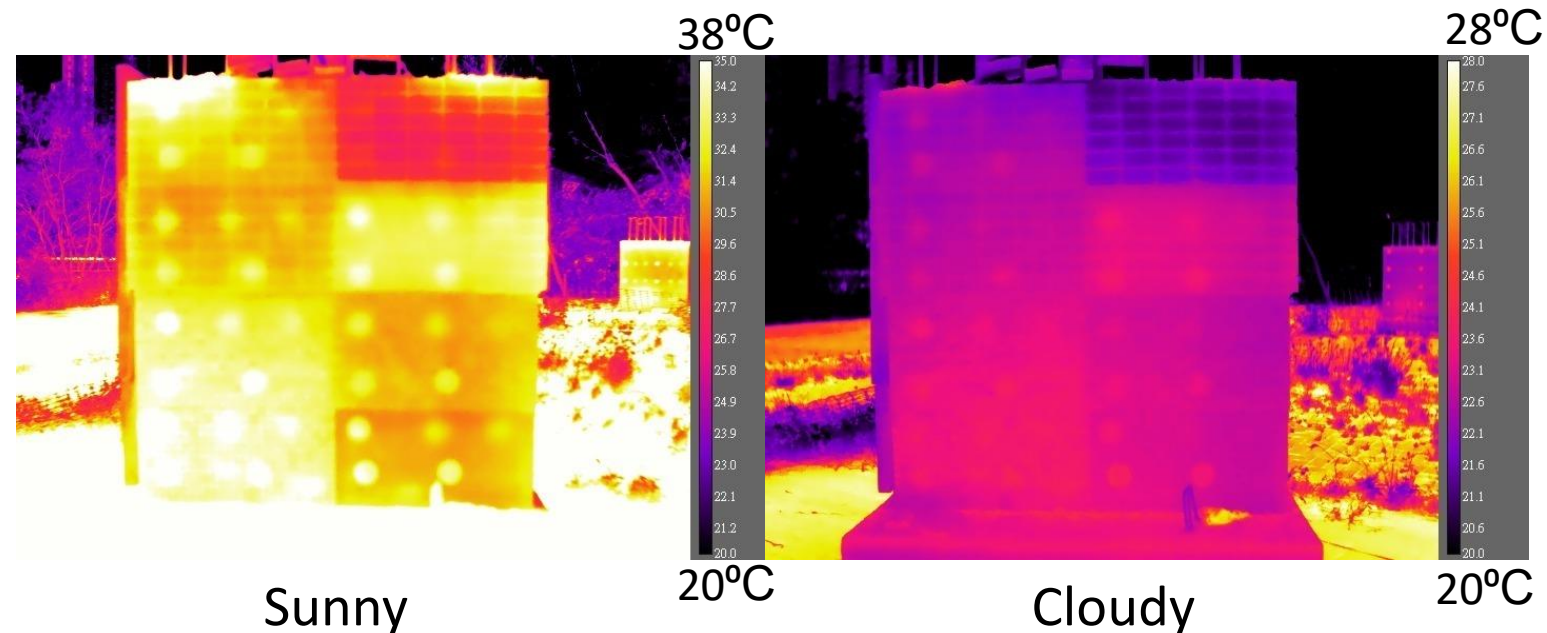
Fine Weather

- Cloud coverage: $< 6/8$
 - Wind speed: $< 6.5 \text{ m/s}$
 - 2-3 days prior to survey
- **at least 12 hours** prior to survey

Bad Weather (i.e. cloudy)

- Haphazard adjustment of temperature bar

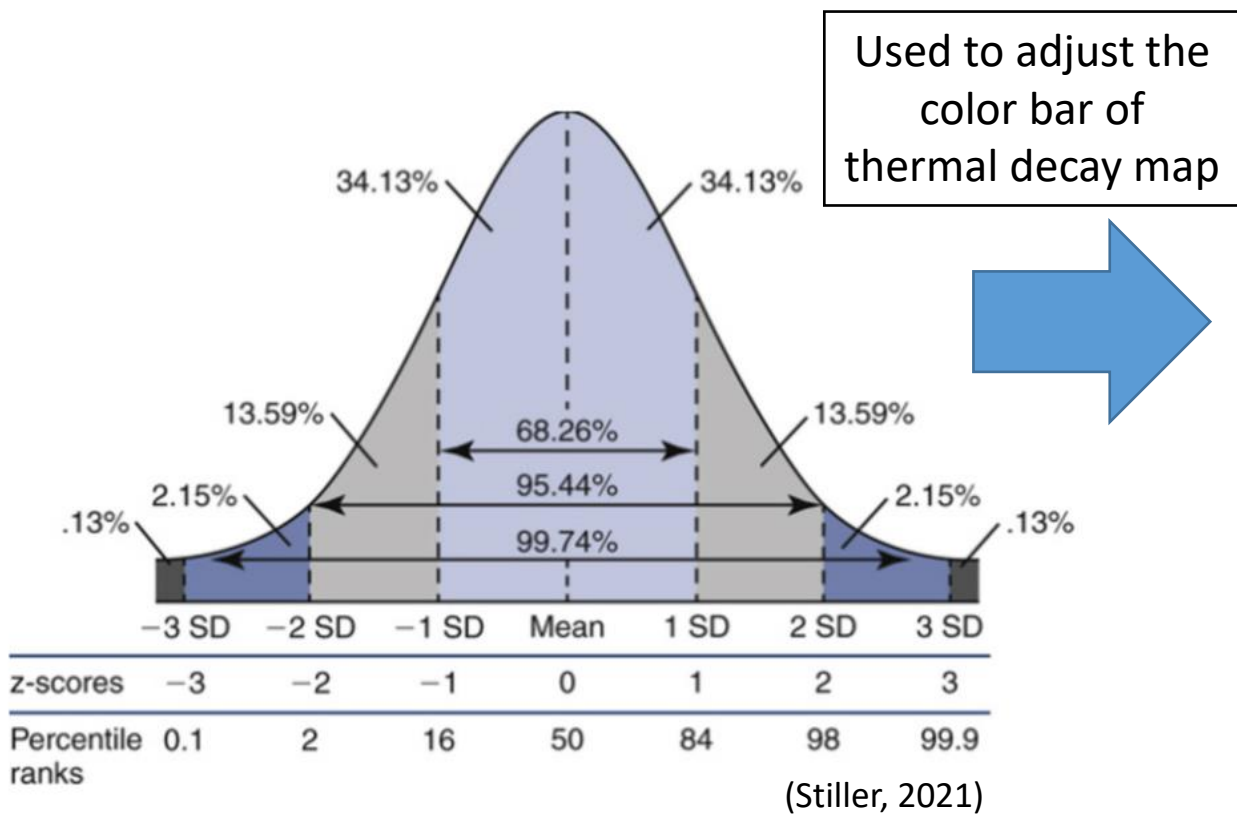
$$\begin{aligned} \max &= \text{Mean}_G + n \times \text{SD}_G \\ \min &= \text{Mean}_G - n \times \text{SD}_G \end{aligned}$$

Thermal Gradient Map
with Normalized Natural Logarithmic Base -
Cooling Phase - 1SD

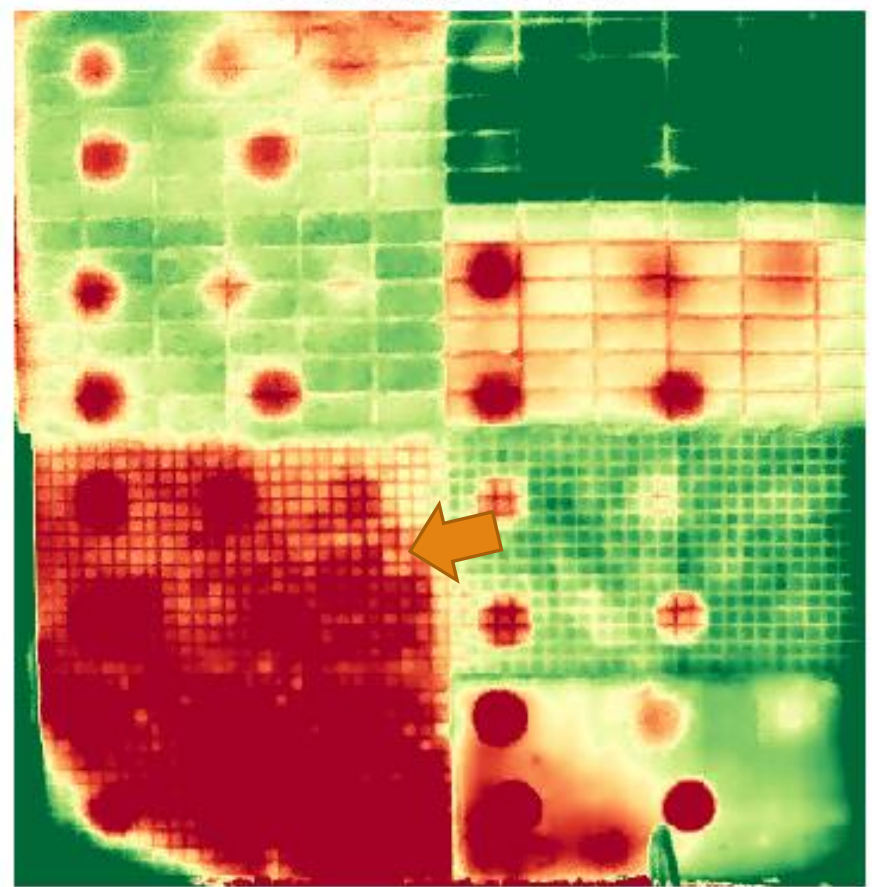
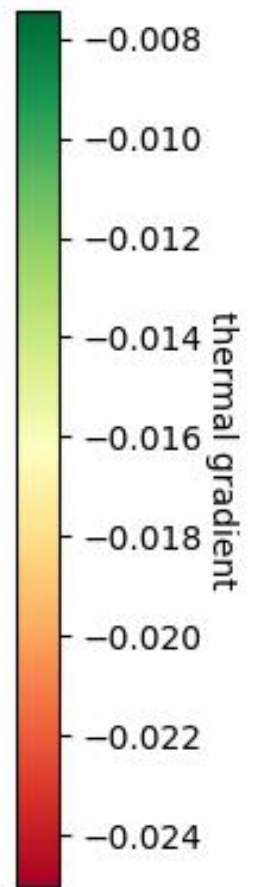
More defects shown
when number of SD
increases.

Thermal Gradient Map
with Normalized Natural Logarithmic Base -
Cooling Phase - 1SD

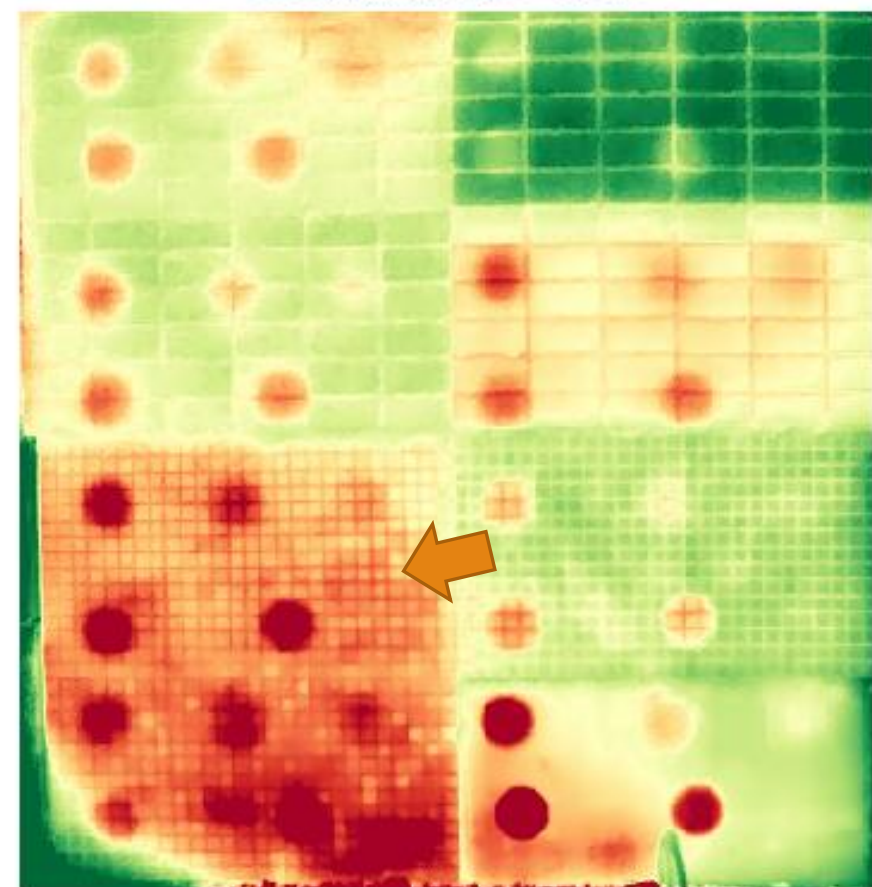
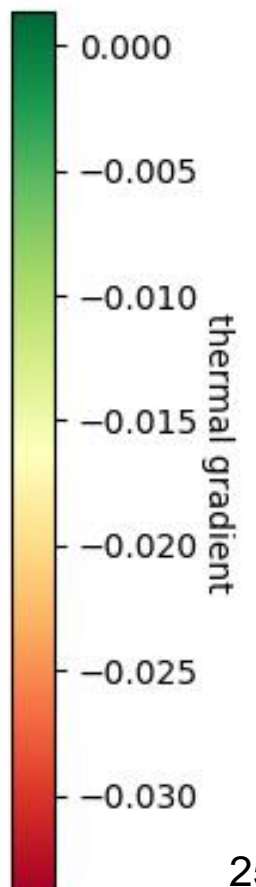
Date: 2018/01/11
Orientation: East
Average Temperature:
12.1 – 16.1°C

Material: Overall
Time: 11:28 – 13:33
No. of images: 26

Thermal Gradient Map
with Normalized Natural Logarithmic Base -
Cooling Phase - 2SD

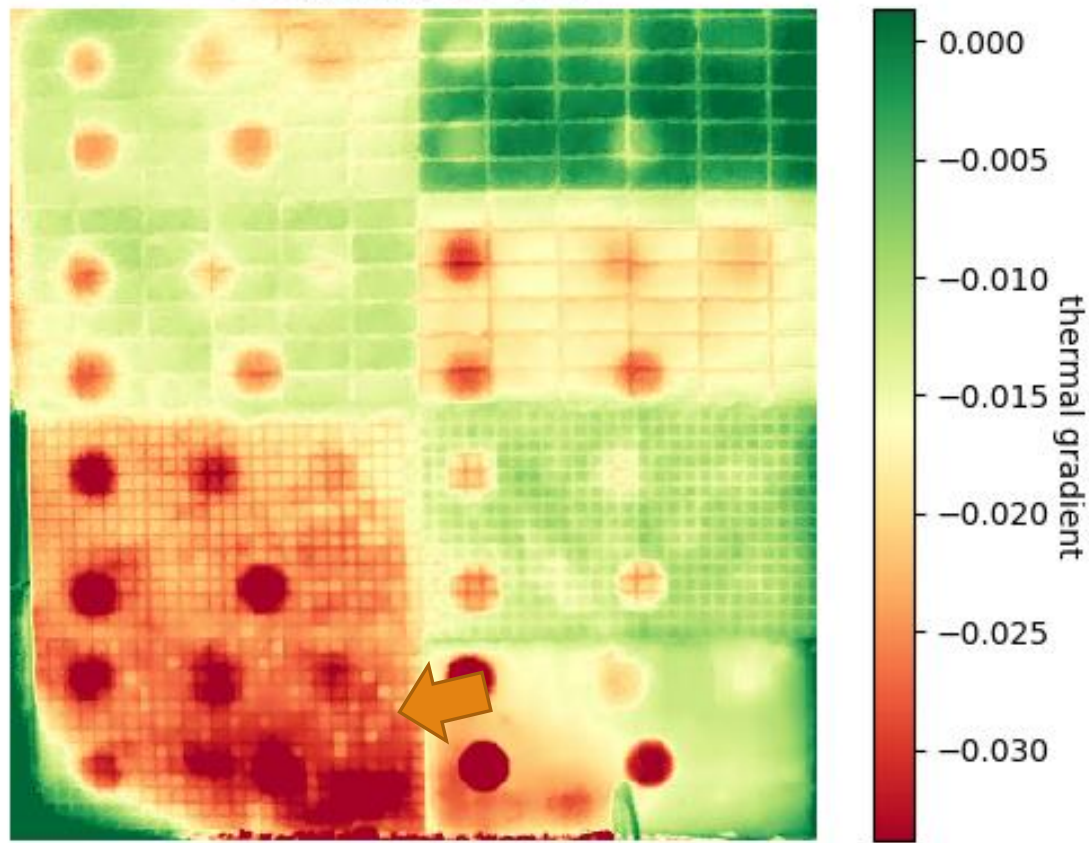
Time: 11:28 – 13:33
No. of images: 26

Thermal Gradient Map
with Normalized Natural Logarithmic Base -
Cooling Phase - 2SD

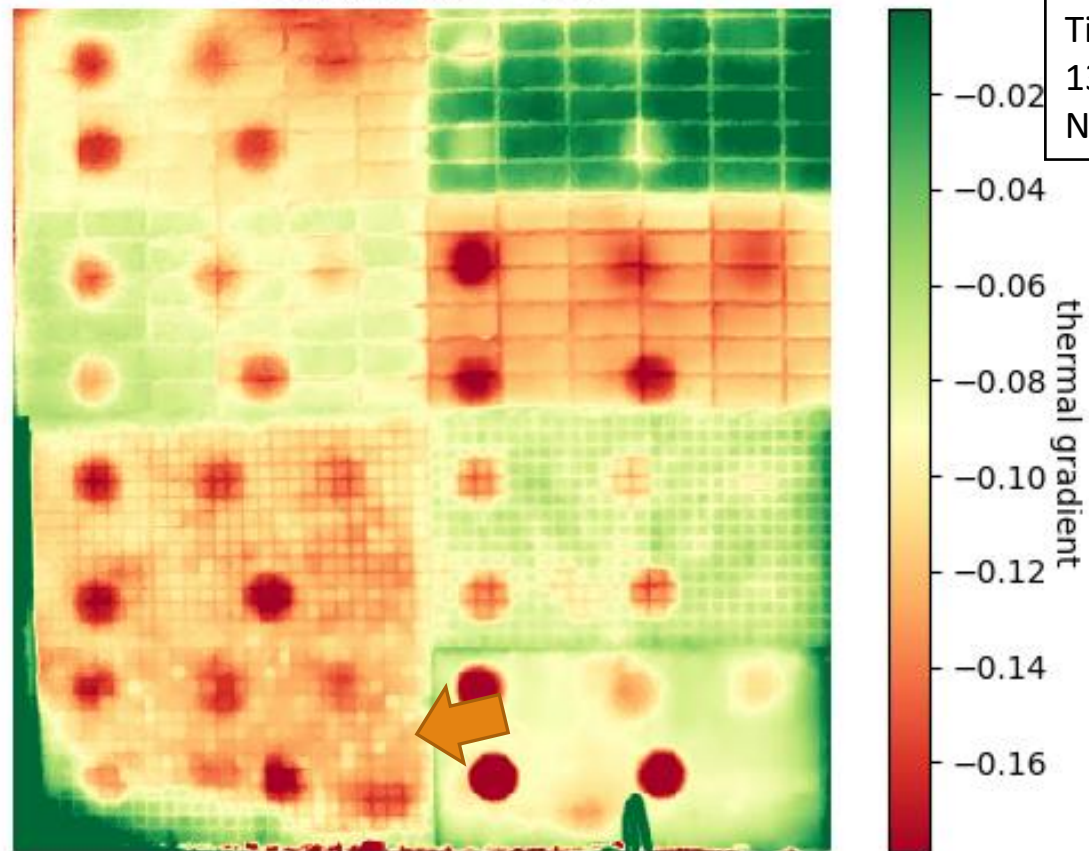
Time: 11:28 &
13:33
No. of images: 2

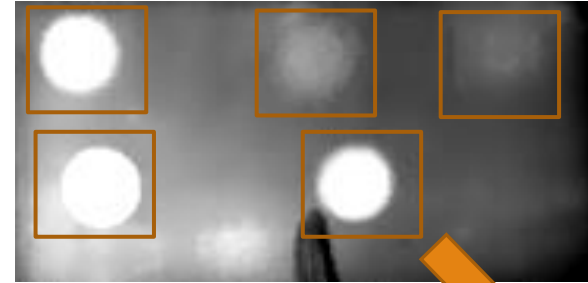
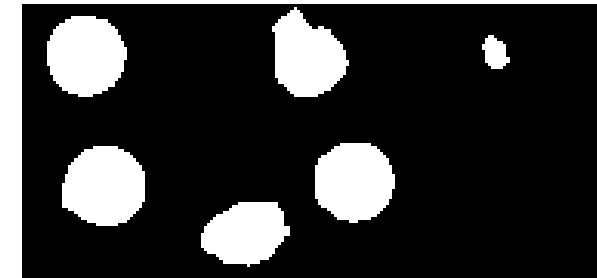
Thermal decay map are separated into 8 sections according to materials

Threshold binary image for size estimation

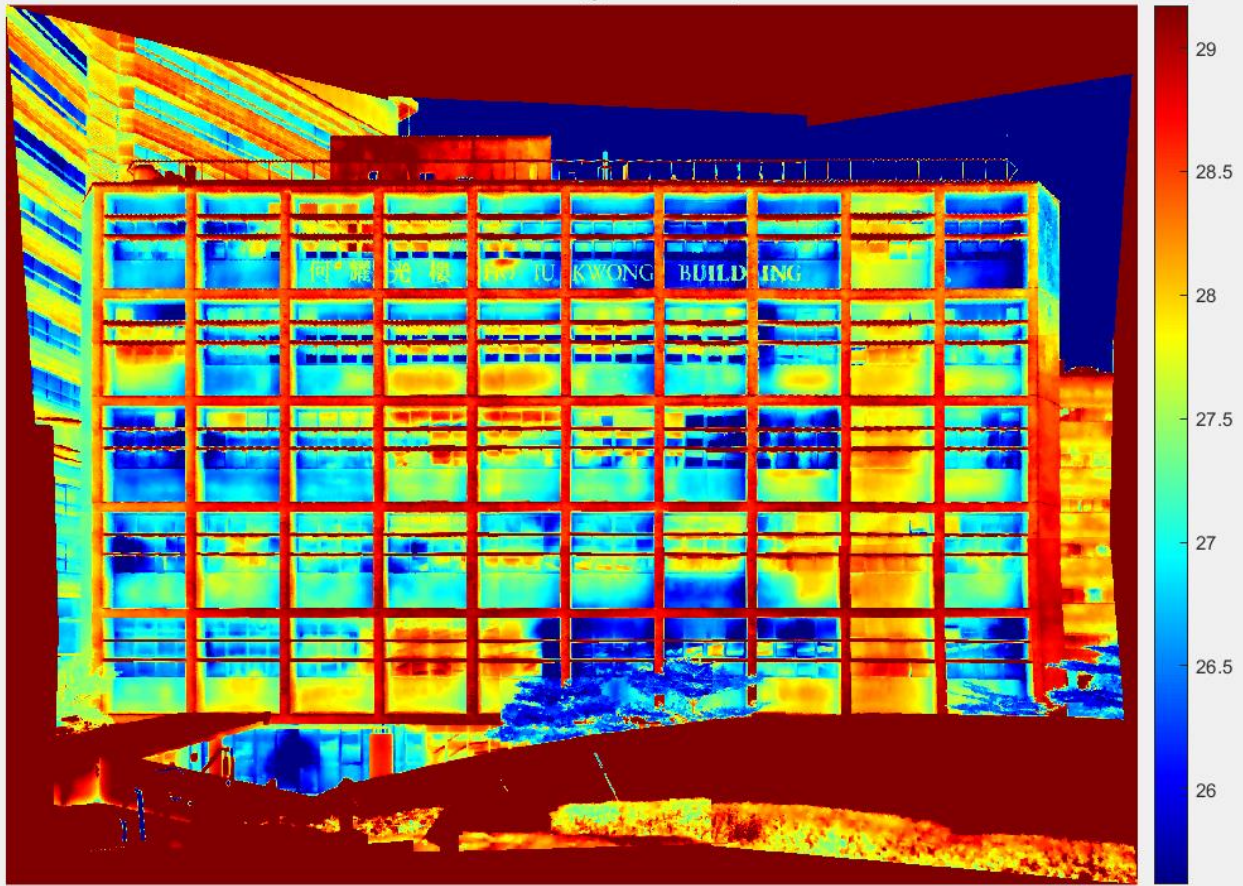
Contrast image in Temp

- Suspected delaminated area
- Check suspected heat source behind the wall/outdoor reflection

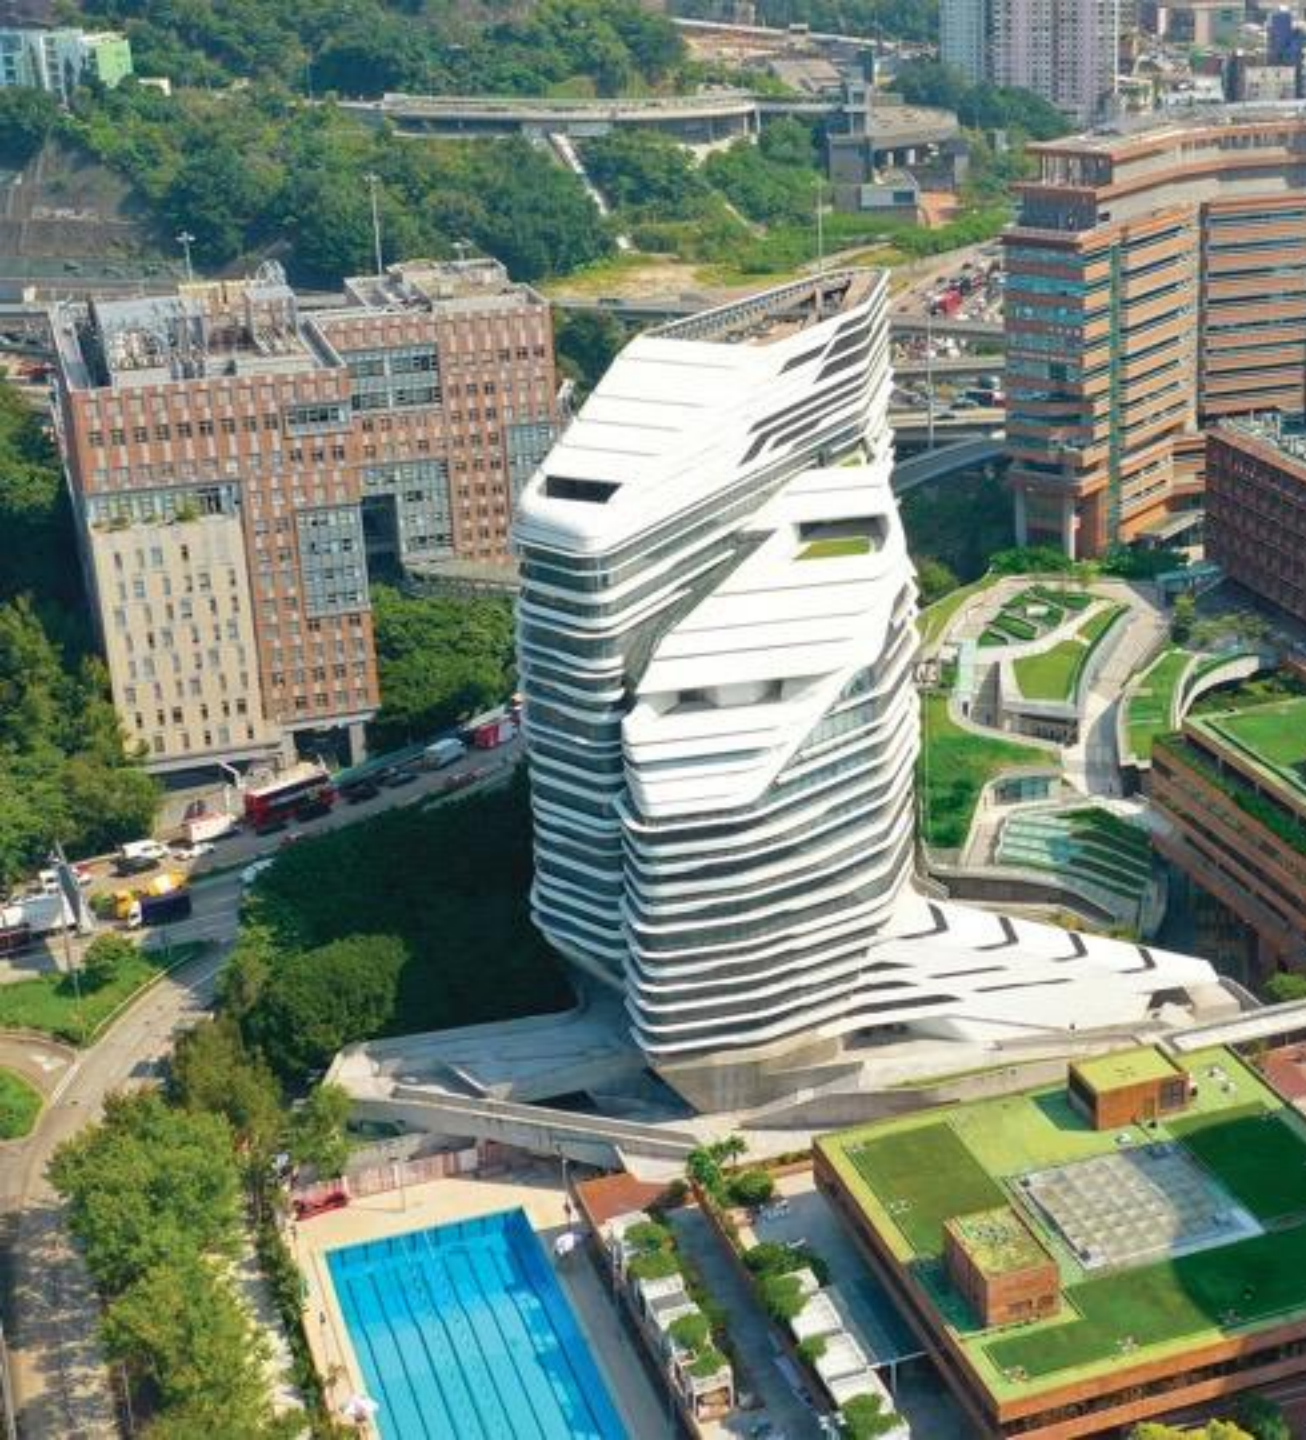
Thresholding to locate defects
